# RESEARCH MEMORANDUM

ALTITUDE-TEST-CHAMBER INVESTIGATION OF THE ENDURANCE AND

PERFORMANCE CHARACTERISTICS OF THE J65-W-7 ENGINE

AT A MACH NUMBER OF 2.0

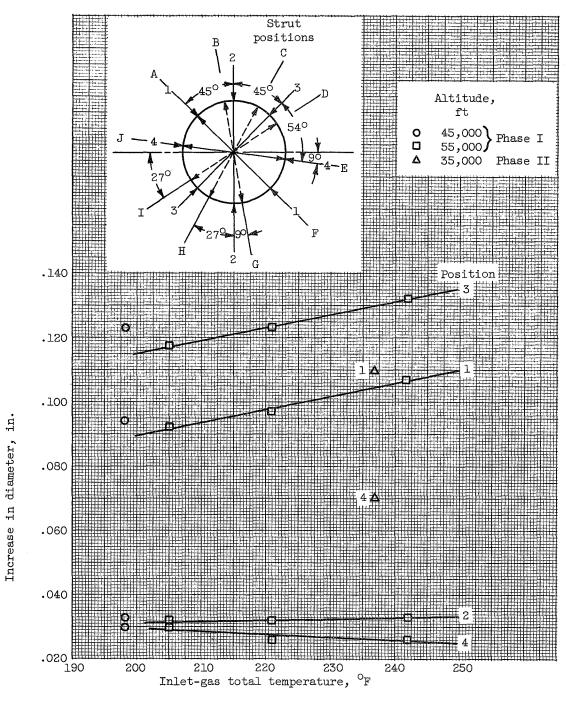
The effect of ram conditions upon the increase in compressor case diameter at station 2.8 is shown in figure 2. From this figure it will be noted that for the engine of phase I the increases in case diameter was more than three times as much for positions 1 and 3 as for positions 2 and 4. For the engine of phase II this difference was much less.

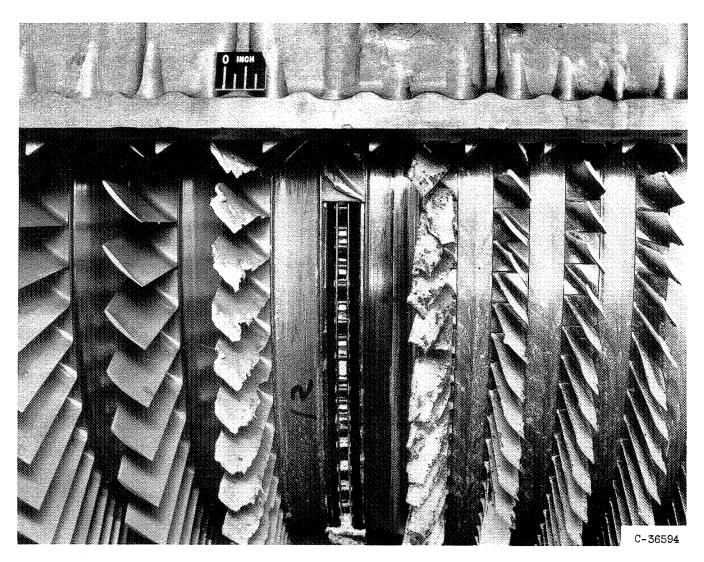
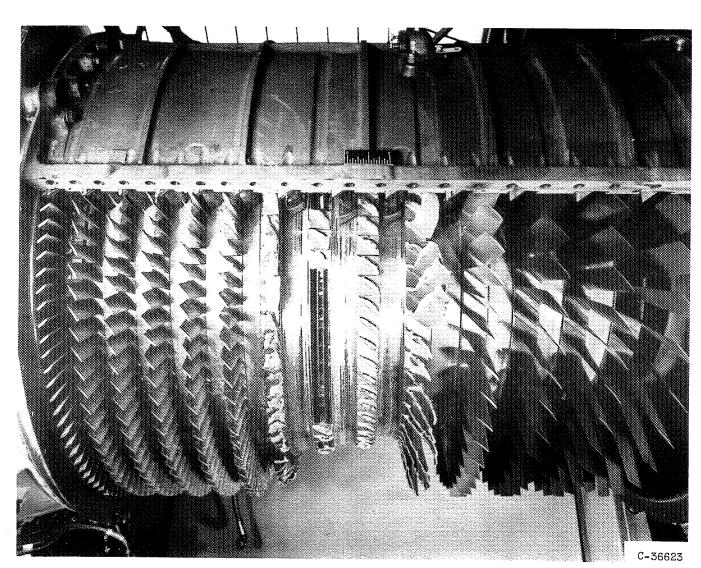
Figure 4. - Compressor rotor of phase I engine showing seventh-stage blade failure.

Phase I tests. - Table I presents a time-history of the phase I tests in which the severity of the inlet temperature and pressure conditions were gradually increased. These tests were terminated by failure of the seventh-stage rotor blading (last stage of aluminum blading). Figure 4 indicates the character of this failure. Failure was accompanied by a slight change in the pitch of the engine noise. The engine continued to rotate smoothly after failure. The compressor housing was dented by the failure, but was still intact.

Examination of the engine after failure indicated that the tang portion of some of the aluminum-alloy compressor blades of the seventh stage failed in tension. The greatly reduced margin of strength of the blade materials at the elevated temperatures involved lends support to this supposition. At the operating air temperature of 480° F and this stage of the compressor, the blade material has a basic yield strength of only 20,000 pounds per square inch, while a simplified stress calculation of the blade tang indicates an operating load of approximately 15,000 pounds per square inch.

(a) Top half of compressor rotor.

(b) Bottom half of compressor rotor.

Figure 4. - Concluded. Compressor rotor of phase I engine showing seventh-stage blade failure.

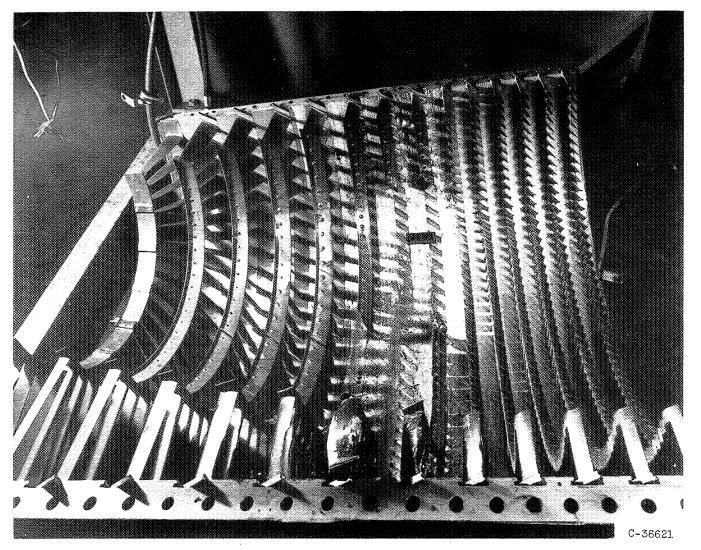
Figure 5. - Failed components of phase II engine.

Phase II tests. - Phase II tests, in which the engine was operated at the most severe inlet temperature and pressure conditions of the program, were terminated by failure of the sixth- and seventh-stage compressor rotor blading (aluminum alloy) and failure of the rotor blading in both turbine stages. Table II presents the history of the operation prior to failure. Figures 5(a) and 5(b) show the character of the compressor failure, and figure 5(c) shows the final condition of the blading of the two turbines. Failure of this engine was accompanied by a thump and a change in the pitch of the engine. The compressor housing was dented, but was not ruptured.

Examination of this engine indicated that rupture of a compressorblade tang was possibly the initial cause of failure. The turbine blading failed from excessive temperatures. Sudden reduction of air flow through the engine following the compressor failure could have caused over-rich fuel-air mixtures and attendant excessive temperatures. The fact that the turbines of the phase I engine remained intact, whereas the turbines of the engine of phase II were severely damaged was possibly caused by the more complete failure of the compressor in the latter tests. Only the seventh-stage blades failed in phase I tests, whereas both sixth and seventh stages failed in phase II tests.

(a) Bottom half of compressor rotor showing failure of sixth- and seventh-stage blading.
